**TESTING ENGINEERS, INC.**

TEI Project No. U173-A 02.15.2007  
Test #2006704, 705, 718, 719  
Page 1 of 20

Subject: 2D Substructure Test - 4ft Standard Wall

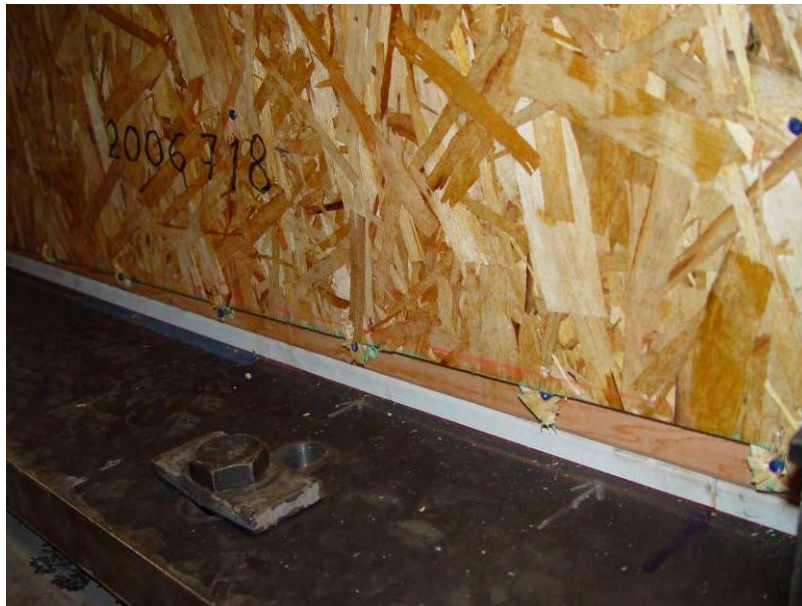
**Figure 8 - Typical Sheathing Nail Tear-Out.**

- **2005-704:** Sheathing nails tore out at sill plate and north corner stud; shearwall north frame member uplifted from the sill; sill plate bending distortion.
- **2005-705:** Sheathing nails tore out at sill plate and north corner stud; shear wall north frame member uplifted from the sill; sill plate bending distortion.
- **2005-718:** Sheathing nails tore out at sill plate; shearwall north boundary member detached from the sill; sill plate bending distortion.
- **2005-719:** Sheathing nails tore out at sill plate; shearwall north boundary member detached from the sill; sill plate bending distortion.

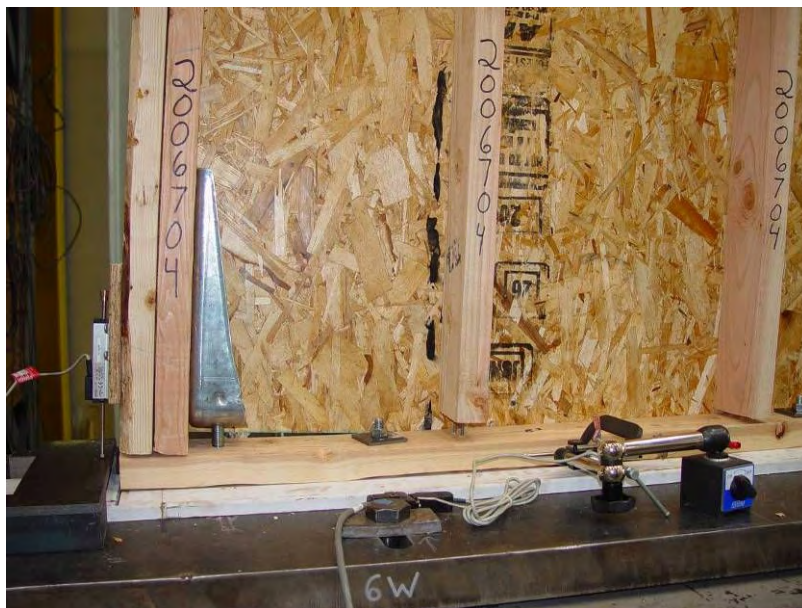
**Figure 9 – Typical Deformation after test.  
<Double corner studs with PhD 5 holddown>**
