**Report No. WMEL 05-069**

**Cyclic Shear Wall Testing on Walls with Large Openings**

**Steve Pryor, P. E., S.E.  
Simpson Strong-Tie Company, Inc.**

**By  
Wood Materials and Engineering Laboratory  
Washington State University  
December 9, 2005**

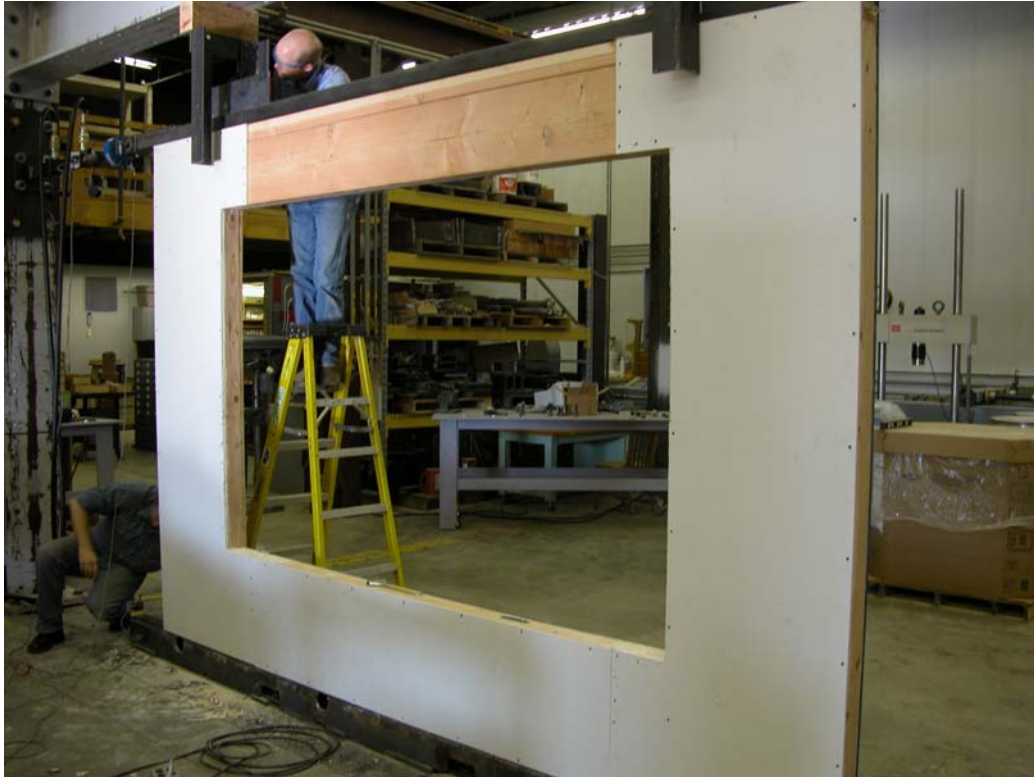
**Figure 3. Typical Wall 4\_1 Specimen Being Installed in Testing Apparatus Prior to Testing.**

Once specimens were fully assembled and fixed to the steel tube attached to the floor, a 3 inch wide steel tube was secured to the top plate or header of the walls using ½ inch diameter lag screws which were staggered at 12 inches o. c. along the length of the walls. This tube was connected to the hydraulic actuator used to induce displacement into the specimens with a connection that allowed rotation between the steel tube and the end of the actuator. Figure 3 shows a test specimen installed in the testing apparatus prior to initiation of the cyclic testing protocol.

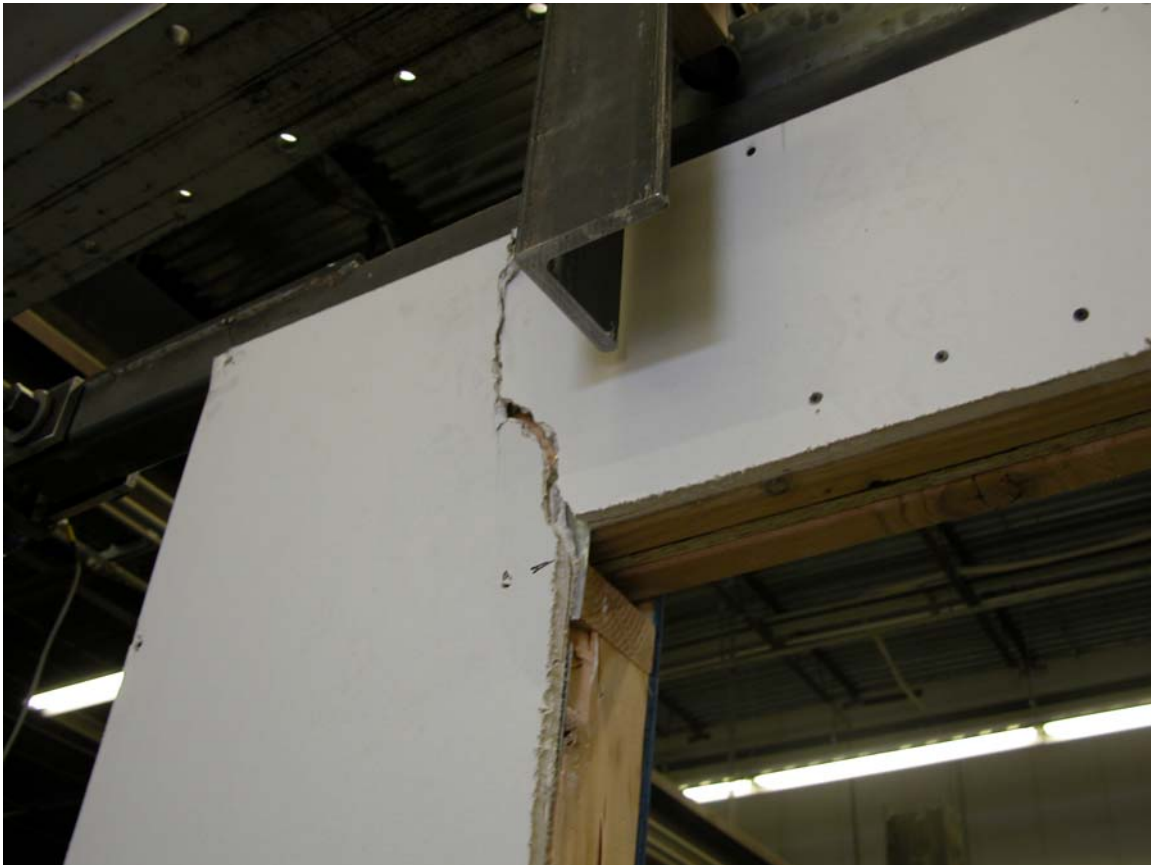
**Figure 4. Typical Initial Failure of Portal Frame Specimens – Cracking of Gypsum Wallboard.**

Typical failure of the portal frame specimens are included in Figures 4 – 7. The typical failure was initial cracking of the gypsum panel at the top of the frame (Figure 4), followed by cracking of the OSB (Figure 5). Then at large displacements, the steel straps at the top of the wall would fail (Figure 6) and the hold-down post would split (Figure 7).

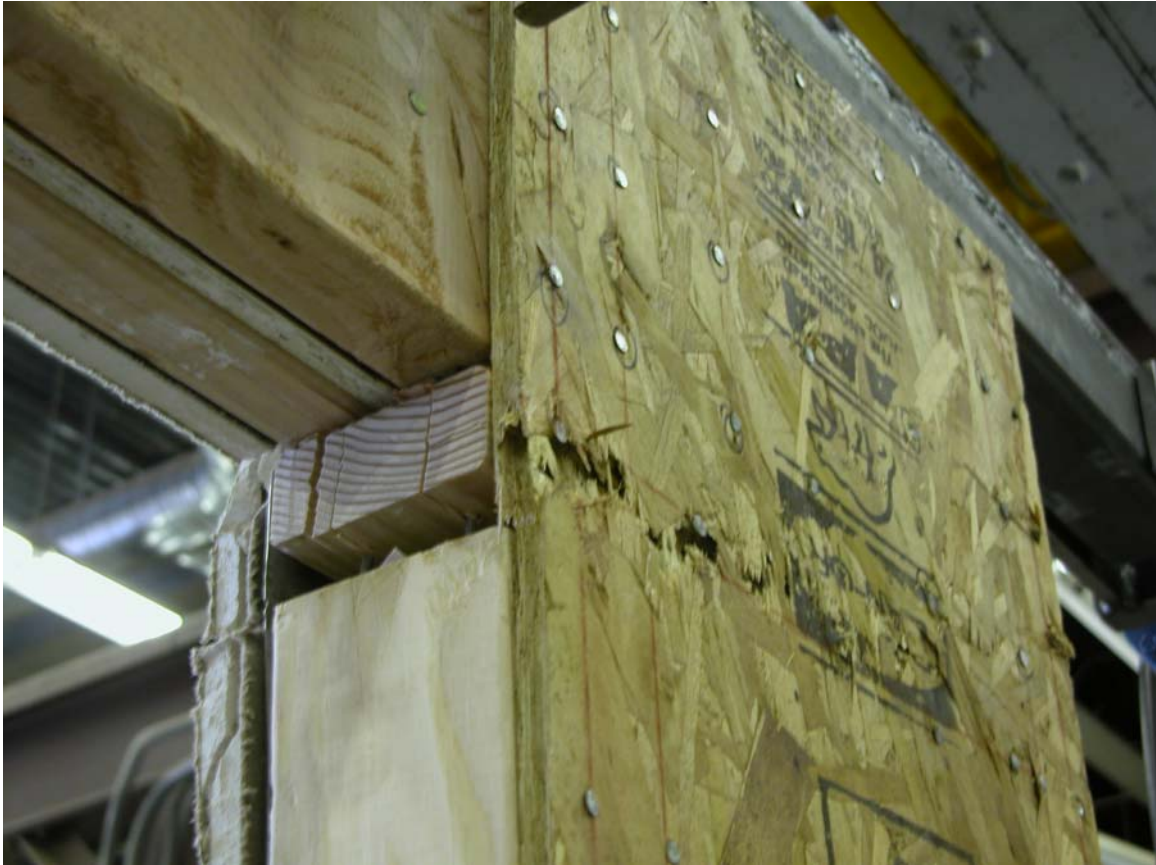
**Figure 5. Secondary Failure of Portal Frame Specimens – Cracking of OSB.**

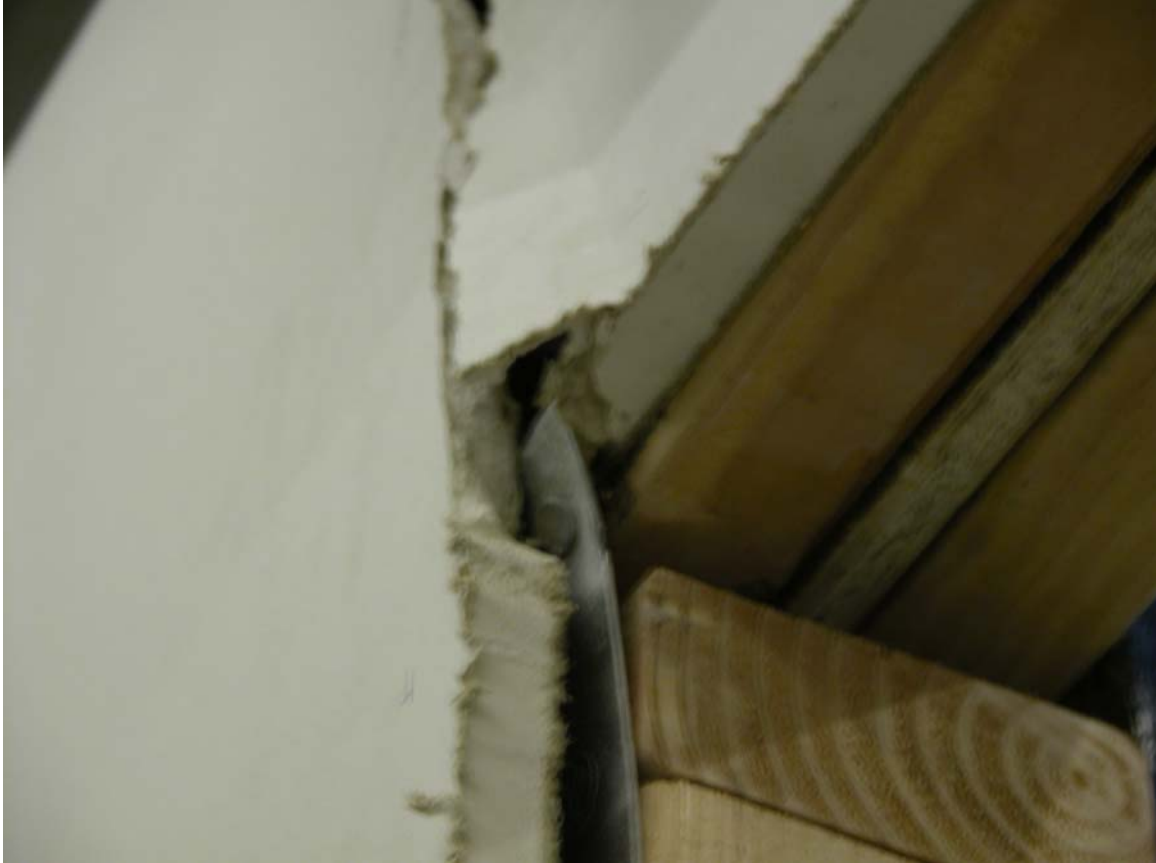
**Figure 6. Location of Third Failure in Portal Frame Specimens – Tension Failure of Straps.**

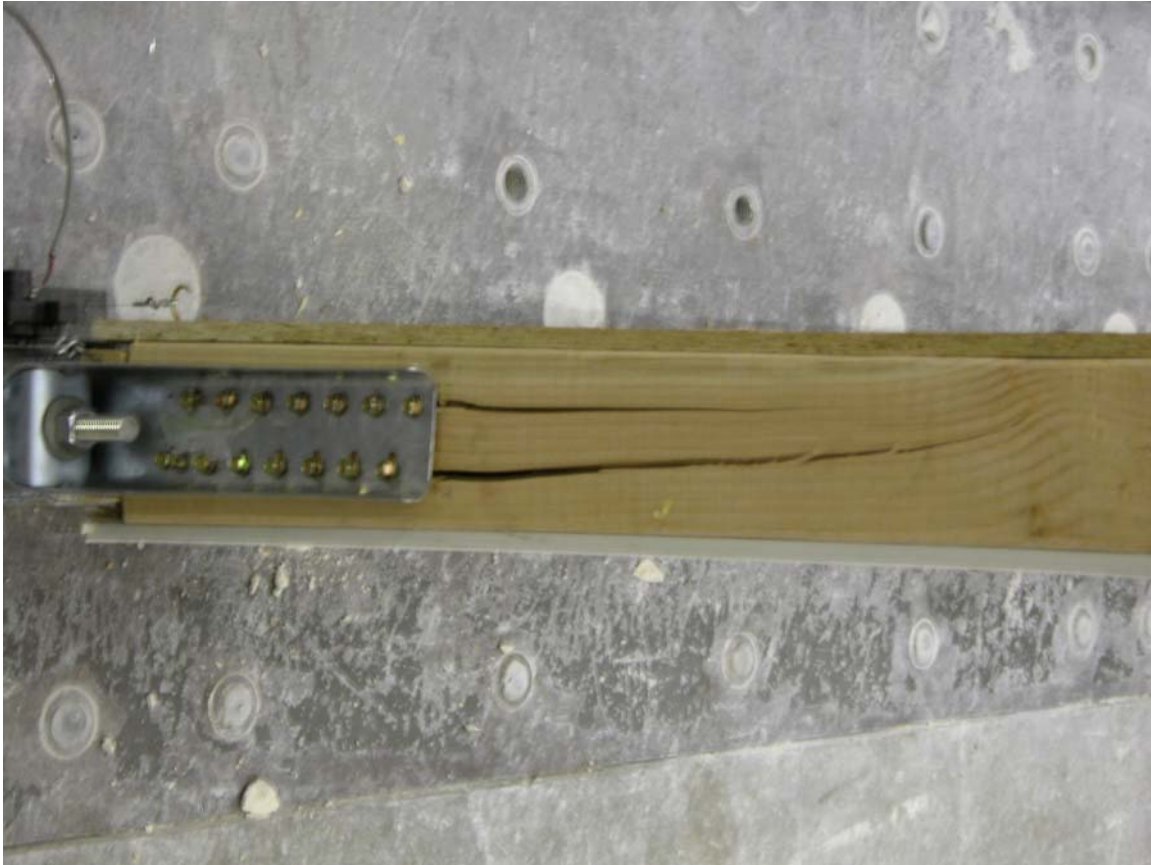
**Figure 7. Typical Failure of Hold-Down Post – Occurred at Large Displacements.**

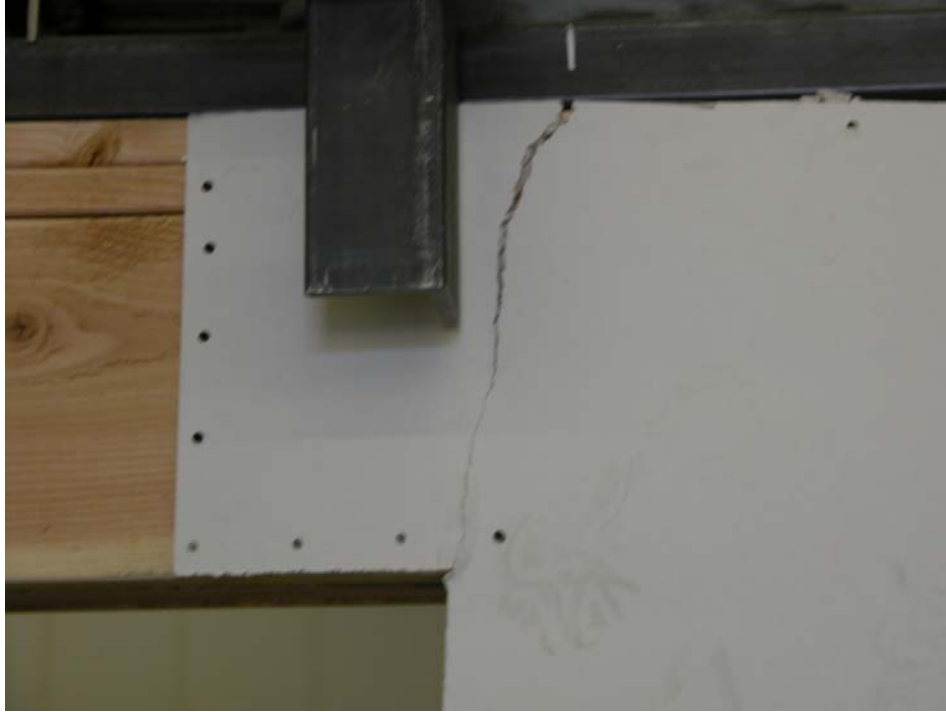
**Figure 8. Typical Initial Failure of 4\_1 Wall Specimens – Cracking of Gypsum Wallboard (shown near top of specimen).**

Typical failure of the 4\_1 Wall frame specimens are included in Figures 8 – 12. Failures were very similar to the portal frame specimens where the initial failure was due to cracking of the gypsum panel near the top of the frame (Figure 8), followed by tear-out of the nails securing the OSB (Figure 9). At larger displacements, there were no steel straps at the top of the wall to hold the segments together, which resulted in continued opening of the cracks in the gypsum and separation of the wall segments (Figures 10 and 11), until applied loads decreased and the hold-down post (where applicable) would split, or the wall segments would be lifted from the bottom plate (Figure 12).

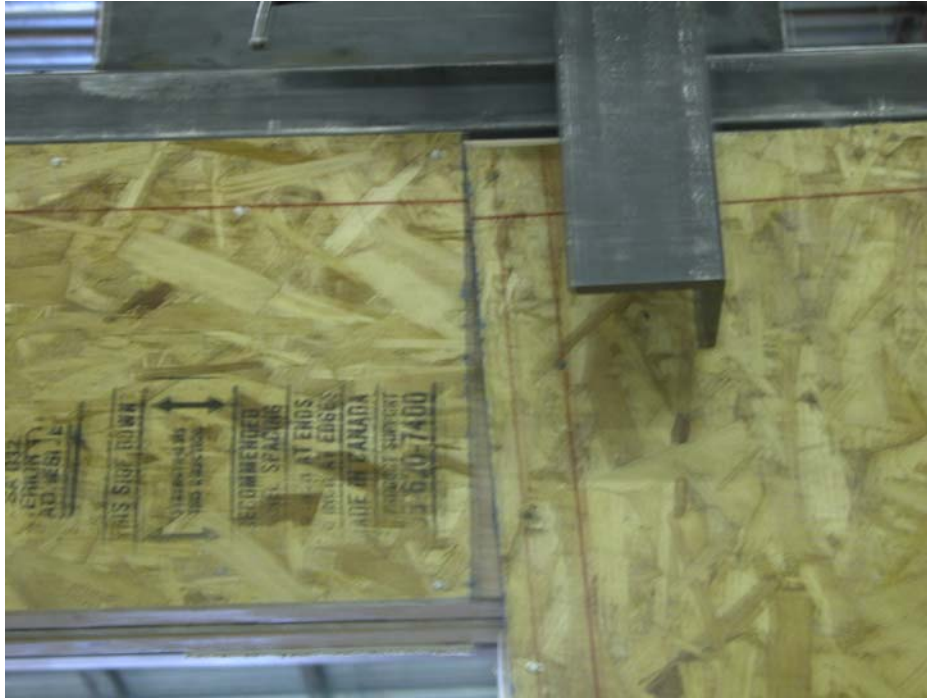
**Figure 9. Secondary Failure of 4\_1 Wall Frame Specimens – Separation and Cracking of OSB.**

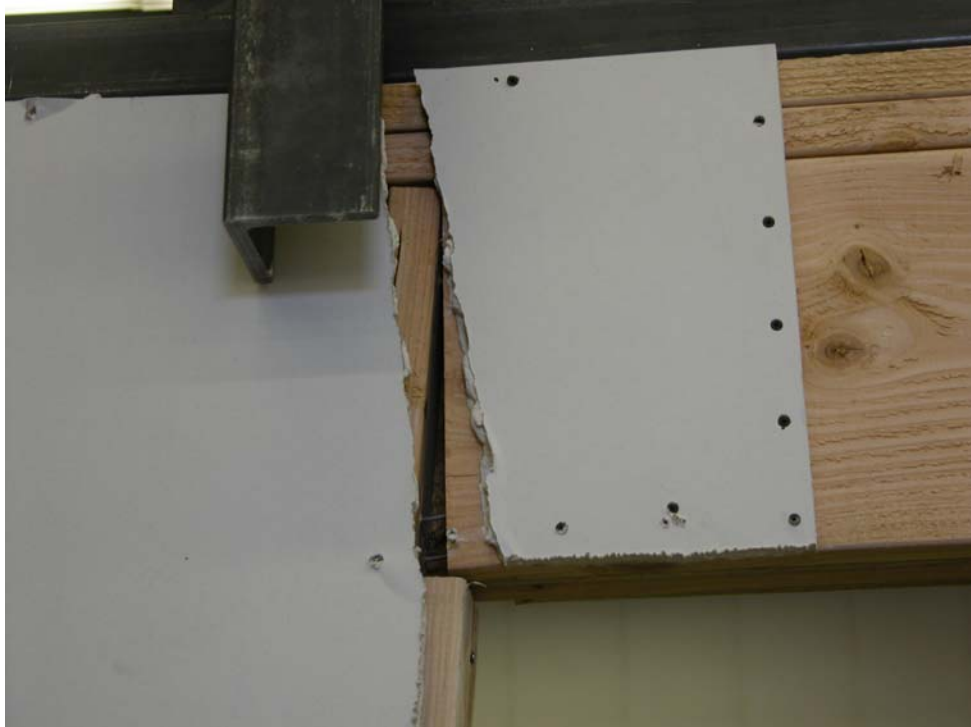
**Figure 10. Continued Failure of 4\_1 Wall Frame Specimens – Further Opening of Cracks in Gypsum.**

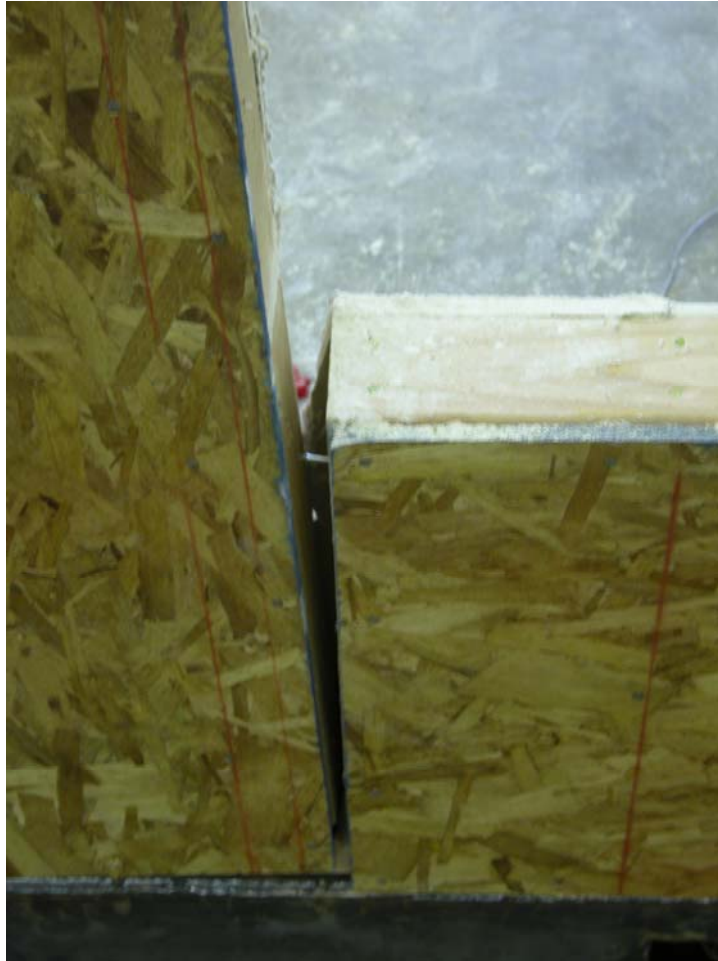
**Figure 11. Continued Failure of 4\_1 Wall Frame Specimens – Separation of Wall Segments.**

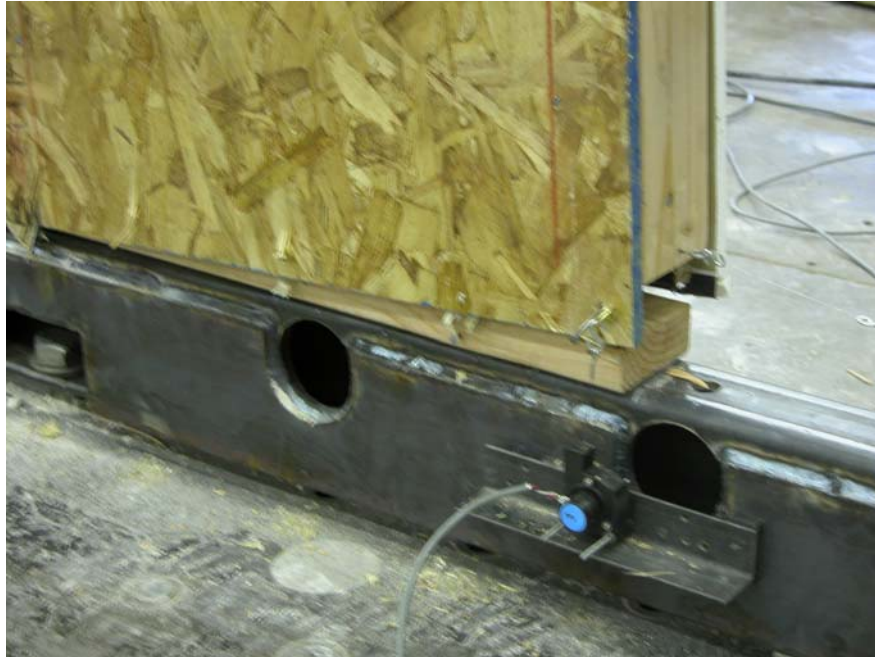
**Figure 12. Lifting of Wall Segment from Bottom Plate on 4\_1 Wall Specimens.**

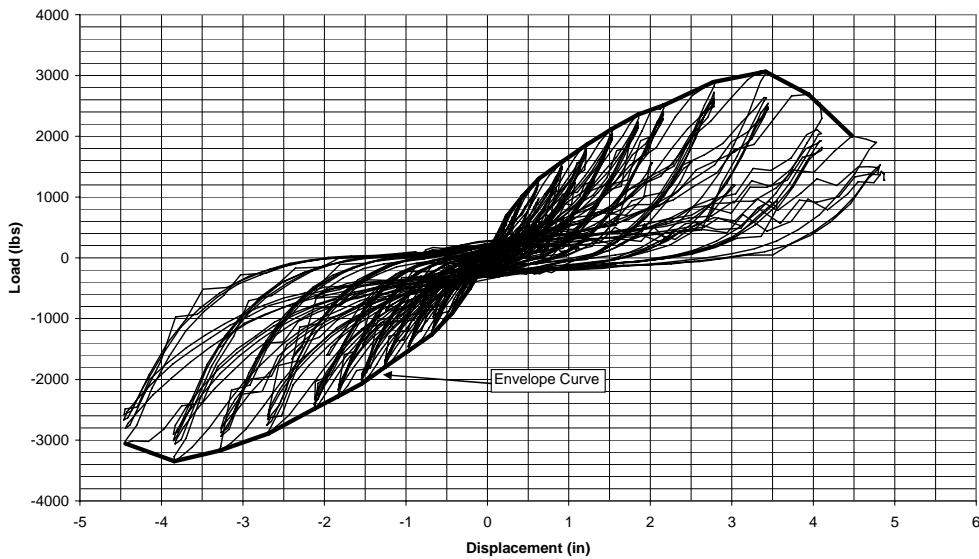
Load-Displacement for 6:1 Wall With Hold-Downs  
(Specimen 1)  
(Slip Corrected Data)

Figure A3. Hysteresis Plot for Specimen 6\_1-3

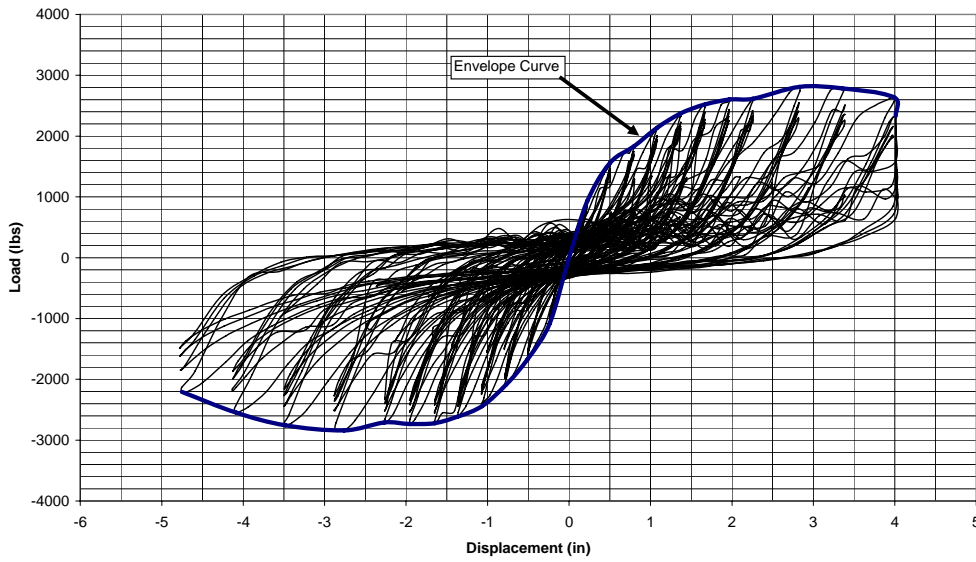
Load-Displacement for 4:1 Wall With Hold-Downs  
(Specimen 1)  
(Slip Corrected Top of Wall)

Figure A7. Hysteresis Plot for Specimen 4\_1-1
